Shortening of high pressure bimetallic urea strippers in situ to extend their operational life and improve reliability

This paper outlines a method to improve the reliability and extend the overall operational life of degraded SAIPEM / SNAMPROGETTI bimetallic HP urea strippers by shortening the tube length and restoring the overall condition of the bottom tubesheet and the tube-to-tubesheet weld joints in situ.

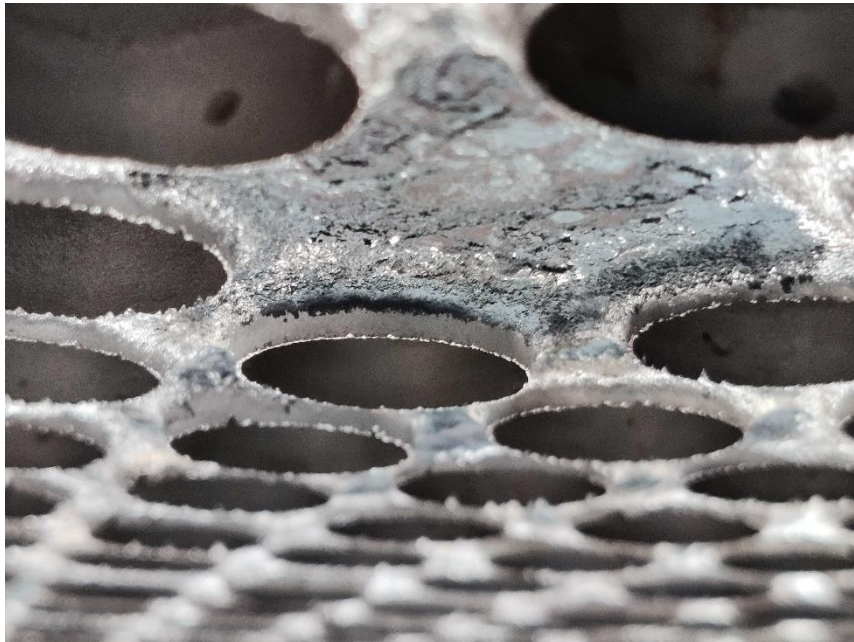
FIGURE 6: THE BOTTOM TUBESHEET SURFACE IN THE CORRODED CONDITION

When properly passivated the bimetallic stripper is quite a reliable piece of equipment. Even so, after the normal duration of its operational life the bottom tubesheet is in many cases the area that determines the decay of the unit and the need for its replacement, with the tube ends and the weld overlay being corroded and sometimes leaks developing in the tube-to-tubesheet welds, especially in units with the short tube protrusion.

In several of these instances of units with a degraded bottom tubesheet and a fairly good condition of the other parts, the procedure for shortening in situ that we developed has provided a significant extension of the equipment operational life and reliability and has consented to postpone the replacement of the equipment by several years.

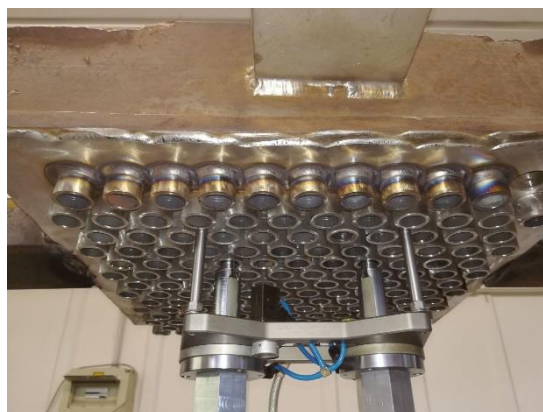
FIGURE 6: MOCK-UP PIECE

Based on that we prepared a mock-up of the tubesheet with the following features:

Note: The external diameter of the mock-up tubes / bore diameter of the mock up piece holes was actually bigger than that of most of the strippers that we shortened because in time the manufacturing specification for stripper bimetallic tubes changed, new strippers have bigger diameter tubes and the older, smaller tubes are not available anymore on the market. This arrangement was accepted as representative of the welds in situ because the resulting tube wall-to-wall clearance was actually smaller than that of the tubes on site.

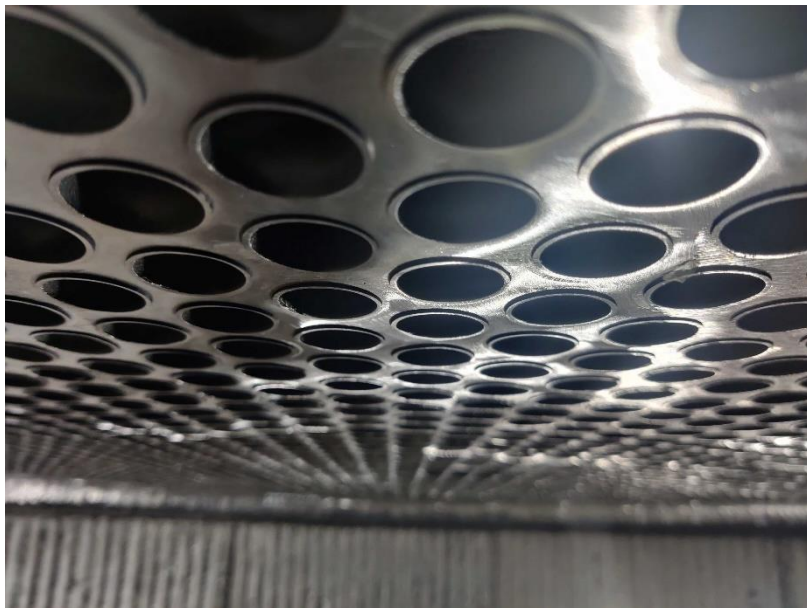
To avoid excessive friction between the tubes and the tubesheet and in order not to introduce unwanted strains on the tubes, the bottom tubesheet should be kept perfectly flat while lifting it. To make sure of that we monitor the lifting movement at 0°, 90°, 180° and 270° by means of 4 comparators and we tighten the bars following a defined sequence.

After lifting the bottom channel by 5-6mm we make a visual examination of the tubesheet surface to check if there are any tubes that do not slide into their holes and free them.

FIGURE 11: ALL THE TTS WELDS ARE REMOVED, THE TUBESHEET IS POLISHED AND THE TUBES START TO SLIDE DOWN WHILE THE CHANNEL IS LIFTED
